# Saddle Lake Lake Level Control Structure Preliminary Engineering Study

**Van Buren County Drain Commissioner**

**Land & Resource Engineering (LRE)**

**Project No. 23-169**

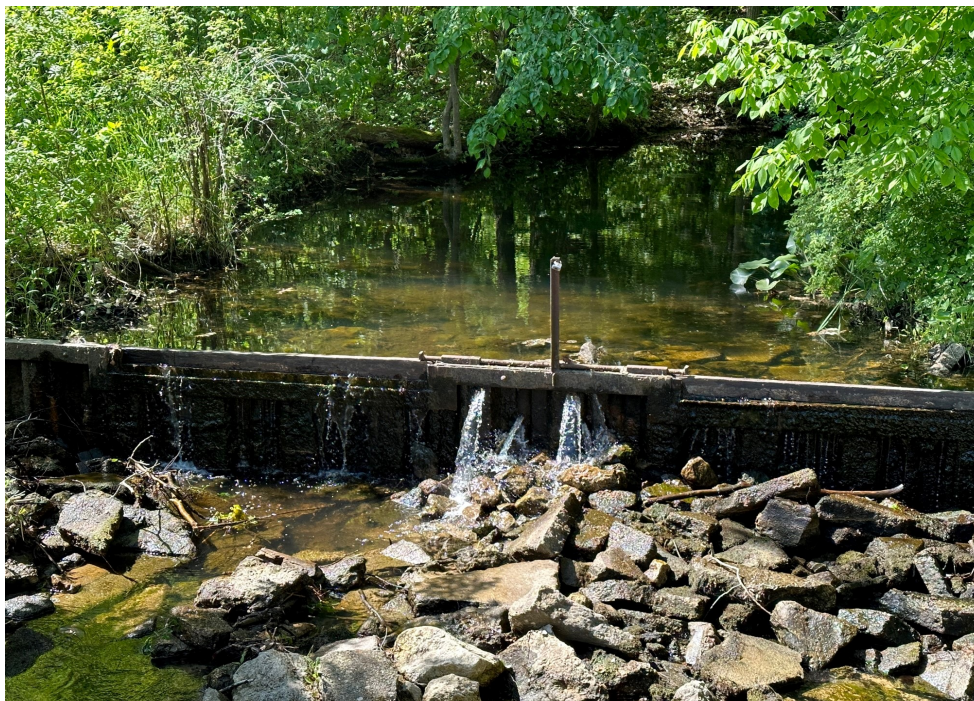
The VBCDC performed the required inspection of the Dam in October 2023 under Part 307 of NREPA. Holes in the sheeting and leaks from the stop log were observed during this inspection. This prompted the VBCDC to pursue improvements to the Dam.

The existing sheet pile Dam has severe corrosion of the steel sheet pile above stream bed resulting in leaks developing through the Dam. The condition of sheeting below the bed of Barber Creek is unknown. The geotechnical analysis results indicate that the existing structure is borderline stable based on the overturning and seepage analysis performed. Additional corrosion of the steel sheeting will develop along the length of the Dam.

**Current Structure - Holes in Metal**

LRE recommends replacing the control structure with a steel sheet pile weir with channel cap in-kind to the existing structure. After discussion with the VBCDC, there have been no complaints regarding the water level elevations in the Lake. Therefore, the in-kind replacement structure was selected.

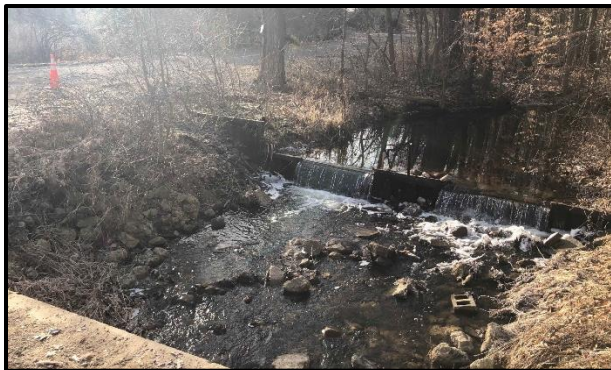
The existing steel sheet pile dam structure appeared to be in fair condition with no obvious signs of structural distress, deflection, cracking or settlement. Water was observed to be flowing overtop of the dam structure (south to north) as designed. No obvious signs of heaving or boiling were observed on the downslope side of the dam structure. A concrete box culvert was also observed north of the dam structure, below the Silver Lake Road roadway, and appeared to be in good condition with no obvious signs of structural distress or settlement.

Existing Dam Structure – Looking Southeast

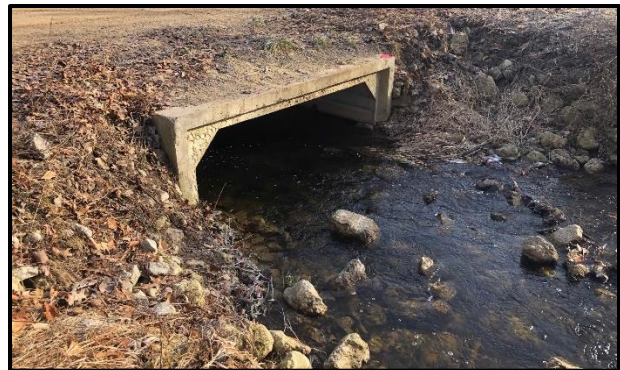
Existing Box Culvert – Looking Northeast

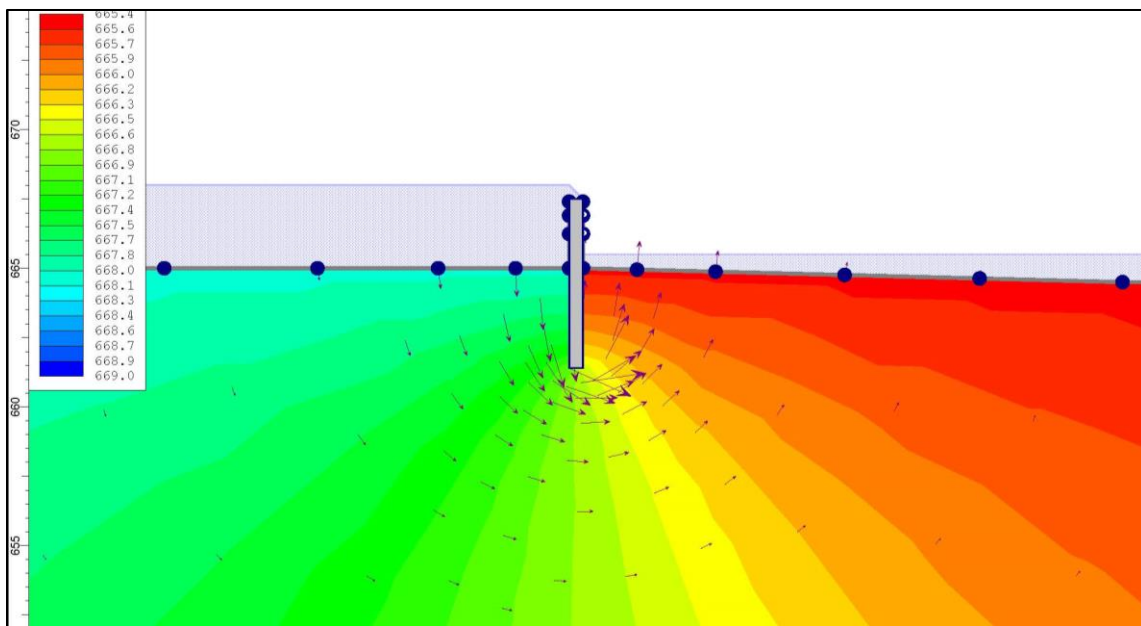
SLIDE Seepage Model – Looking West

MTC's overturning and seepage analysis indicates that the existing structure is *"borderline stable regarding the overturning stability with an estimated Factor of Safety of 1.0 and exit gradient in excess of 0.5."* MTC recommends the sheeting be driven to a minimum elevation of 659.4-feet and have a section modulus of 15.3 cu.in/ft to provide suitable Factors of Safety.

Safety against bottom stability and overturning stability failure while resulting in  $\frac{1}{4}$  inch or less lateral deflection at the top of sheeting. Our analysis considered sheeting section loss for a PZ22 sheet pile per the MDOT Bridge Design Manual Appendix 7.03.08D (nominal section modulus of  $18.1 \text{ in}^3/\text{ft}$ , effective section modulus of  $15.3 \text{ in}^3/\text{ft}$ ).
