# **Van Buren County Land Bank Authority**

## **Request for Proposal General Contractor - Abatement & Building Stabilization**

5 W Main Street  
Hartford, MI 49057

**Attachment 4 – Structural Assessment from Abonmarche (2025)**

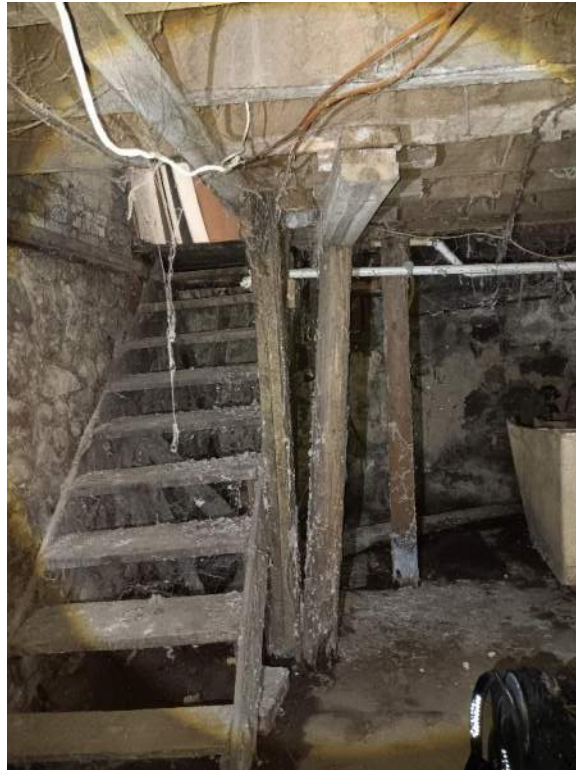
The lower level walls and framing appear to be in good condition. The basement was noticeably damp and evidence of water infiltration was visible. The posts supporting the framing around the opening have water damage at their base and do not appear to be installed plumb (Photo 1).

Photo 1: Floor framing at lower level stair.

We recommend removing and replacing the framing that supports the basement stair opening. Details for this repair can be found in the attached repair drawings.

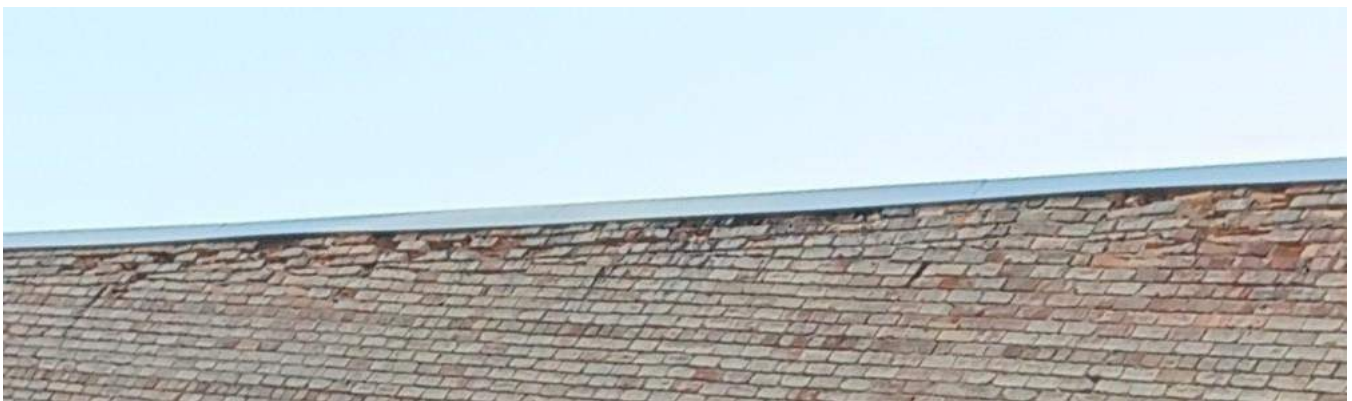
The west side of the building consists of exposed brick and appears to be deteriorating along the roof parapet elevation (Photo 2). Cracked, spalled, and missing bricks were observed along the length of the parapet cap on the west side of the building. Missing bricks were also observed along the base of the wall and around window openings (Photo 3)(Photo 4)(Photo 5).

Photo 2: Top of parapet along west side of building.

We recommend that access to the roof be provided to determine what the condition of the existing roof is and determine if any water is infiltrating into the roof framing. The brick along the top of the roof parapet should be repaired. It is possible that water is passing through the deteriorating brick at the parapet elevation and causing damage to the roof framing.

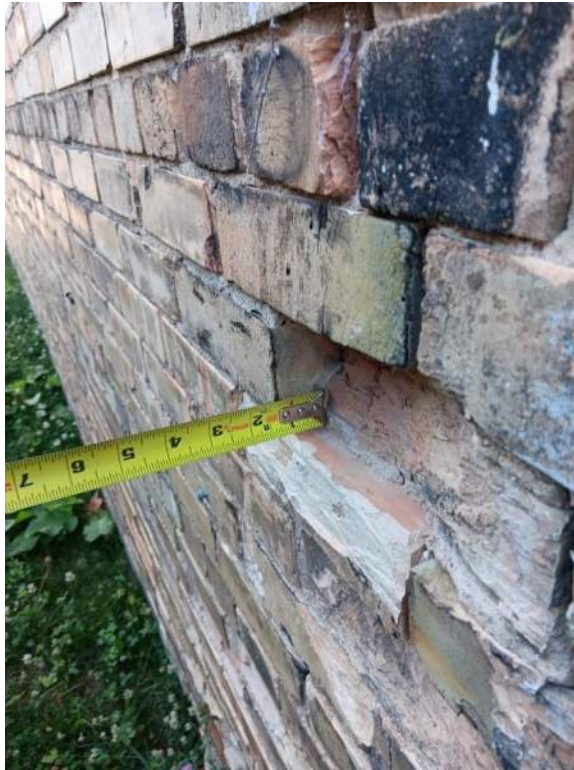
Photo 3: Missing brick along west side of building.

We recommend that all loose and missing bricks be reset and/or replaced where necessary. These locations are primarily along the west and north walls. All deteriorated mortar joints should be repointed. The existing wood framing protruding out of the north wall should be removed and the resulting opening should be infilled with new brick. The contractor should verify that the framing is not part of the existing floor framing on the inside of the building. If it is found to be part of the floor framing it should be cut back sufficiently such that at least one brick wythe can be installed over it.

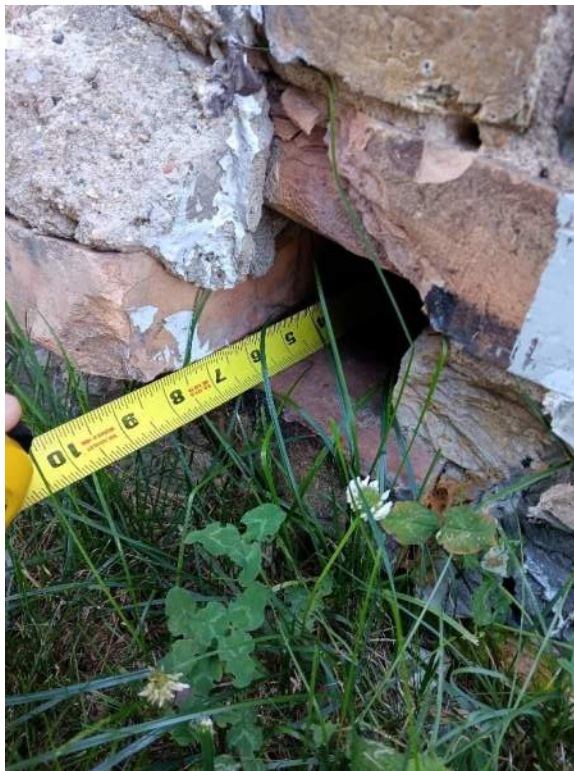
Photo 4: Missing brick along west side of building.

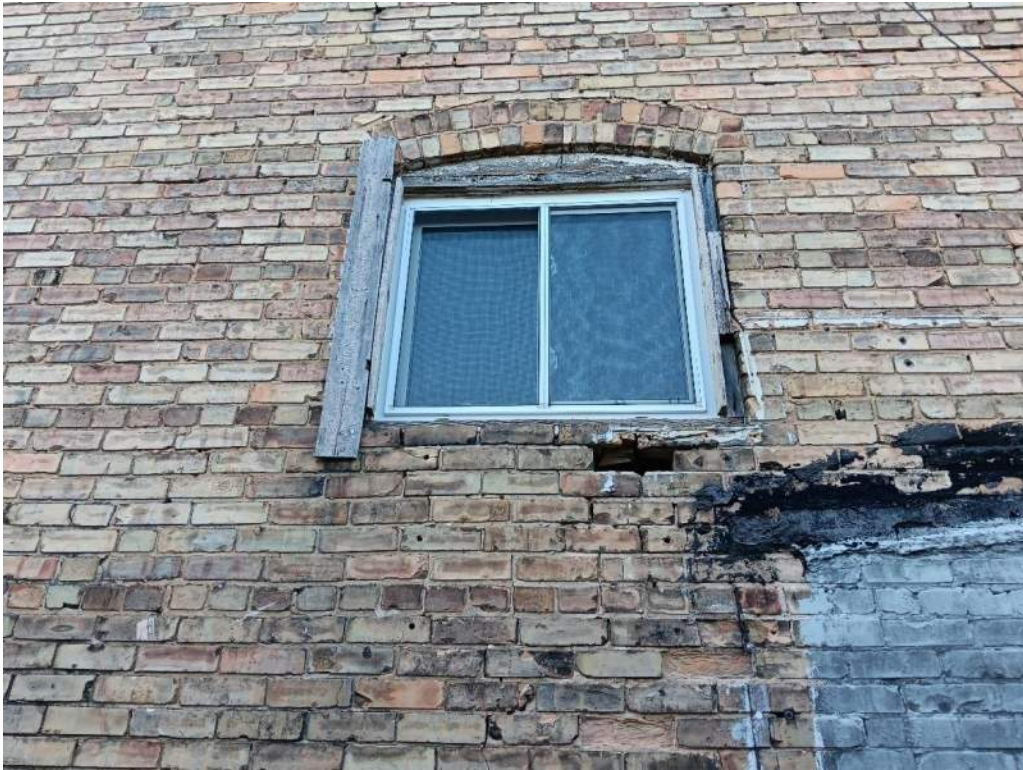
Photo 5: Missing brick around window on west side of building.

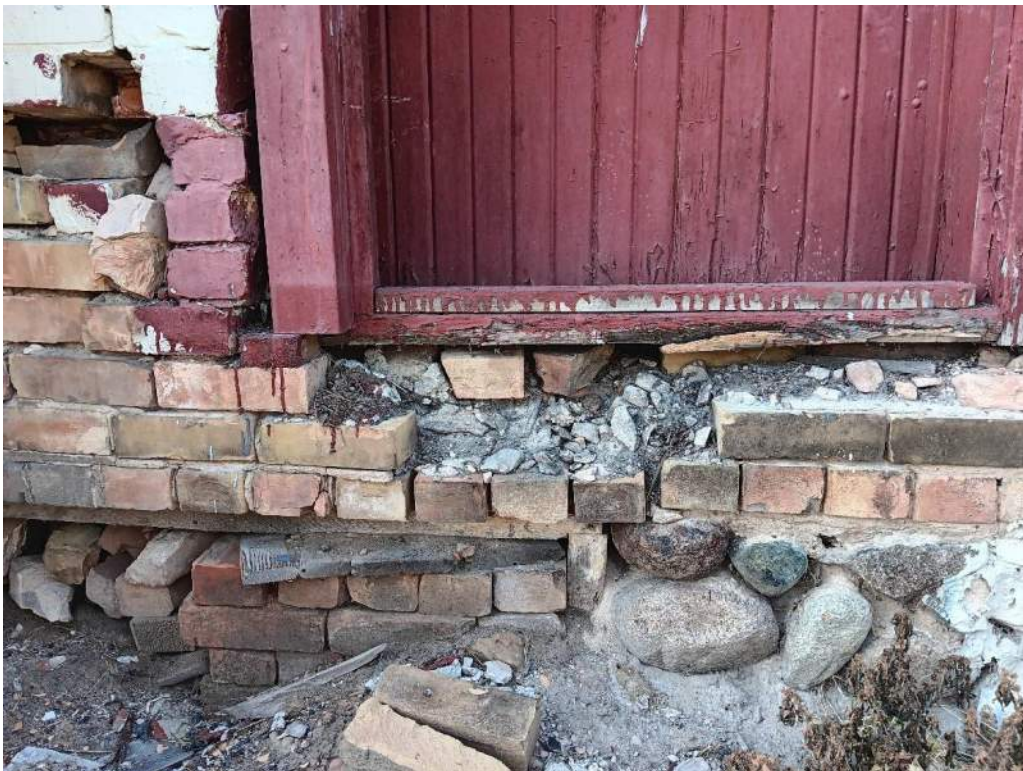
With the removal of the wood framed addition on the north side of the building the brick wall is now exposed. Numerous loose bricks were observed at and around the door openings. Loose bricks are being used as infill for the lower level window openings (Photo 6). Numerous cracks in the mortar joints were observed in the wall. There is existing wood framing protruding through the wall at the first floor elevation that was cut off as part of the demolition of the north stair (Photo 7).

Photo 6: Missing and loose bricks on north side of building.

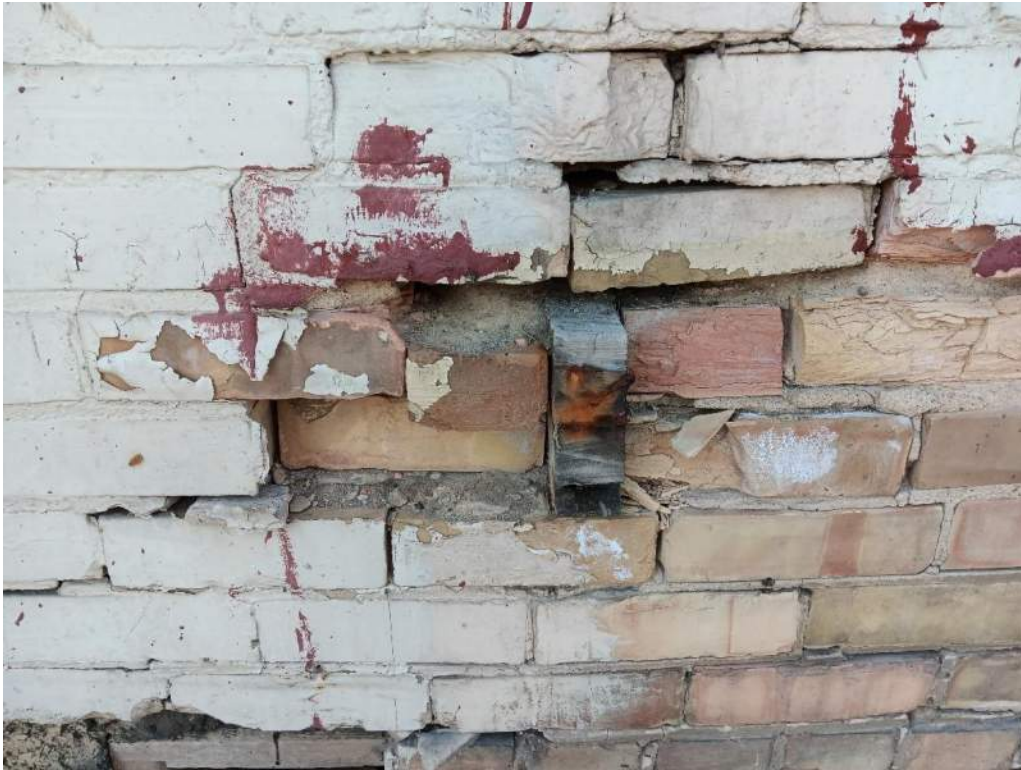
Photo 7: Floor framing embedded in brick wall.

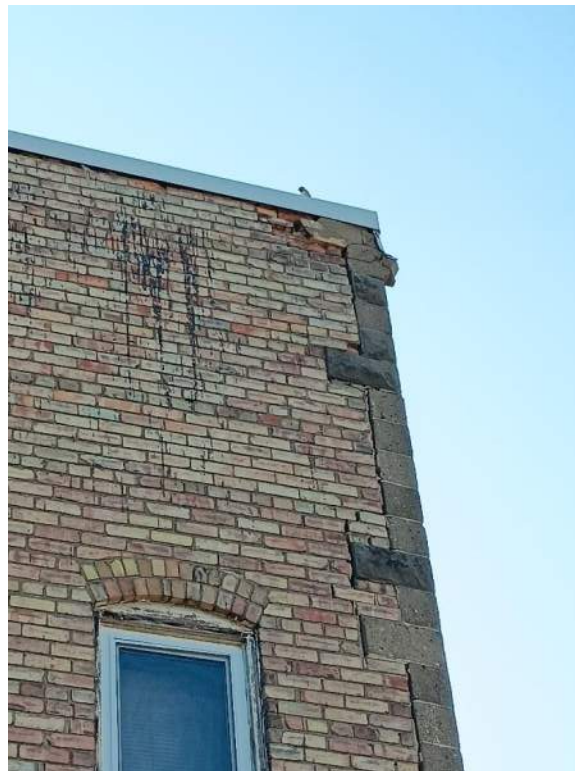
The south face of the building is constructed with concrete masonry units (CMU). The south wall is built integrally with the west wall with intermittent CMU's mortared to the brick (Photo 8). There is a gap between the south and west walls and the south wall appears to be separating from the building. The cornice at the top of the wall appears to be cracked and broken (Photo 9).

Photo 8: Southwest corner of the building. CMU wall appears to be separating from the brick wall.

We recommend that all the joints connecting the south CMU wall to the east and west brick walls are repointed to ensure a positive connection between the two walls. The vertical joint between the walls should be filled with backer rod and sealed. We recommend that the connection between the wall and the second and third floor framing be investigated. The CMU wall should be attached to the floor and roof framing per the detail in the attached drawings. The cornice at the top of the south wall should be investigated more closely. We recommend that any broken, cracked, or loose pieces be removed. They appear to be hazards to pedestrians on the sidewalk below and should be repaired or removed as soon as possible.

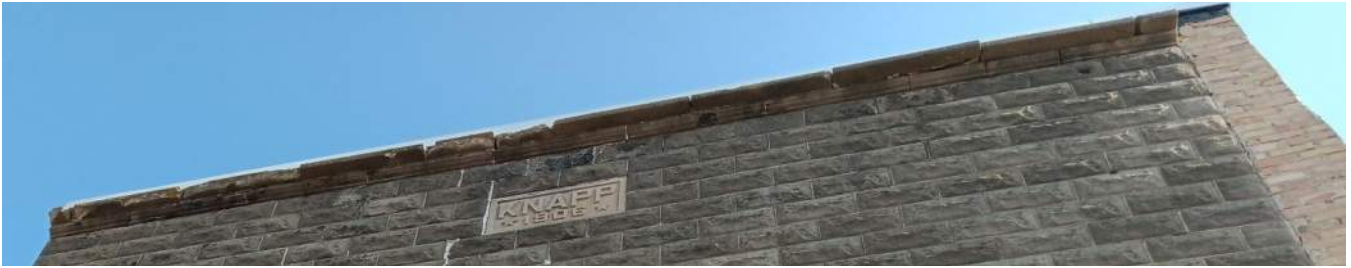
Photo 9: Cornice along top of south wall is broken.

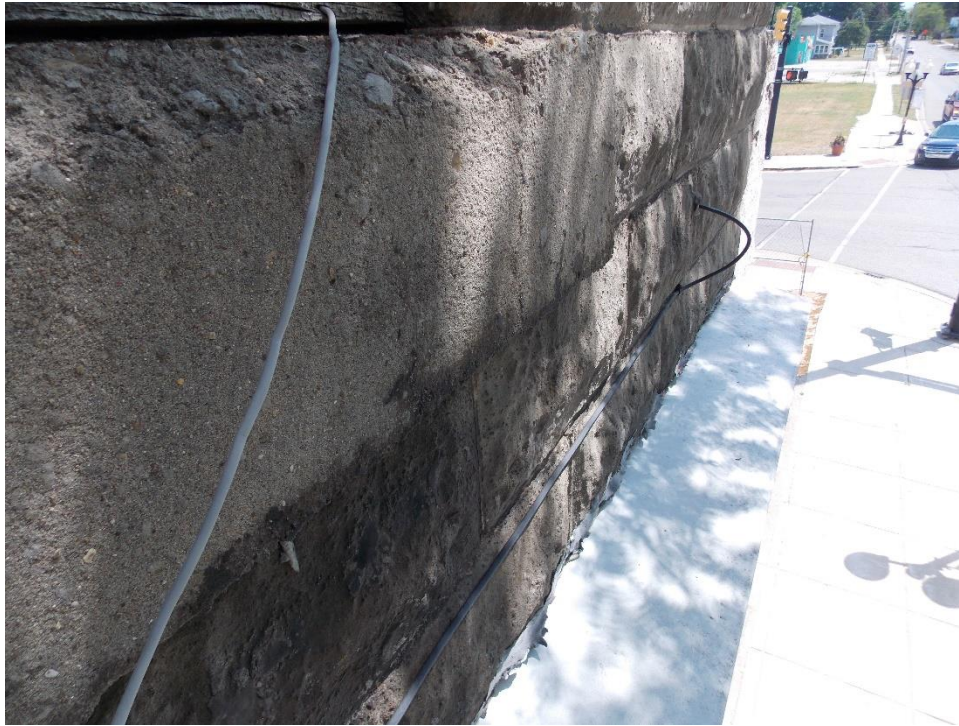
HA-04: 2nd Floor Flashing Tar

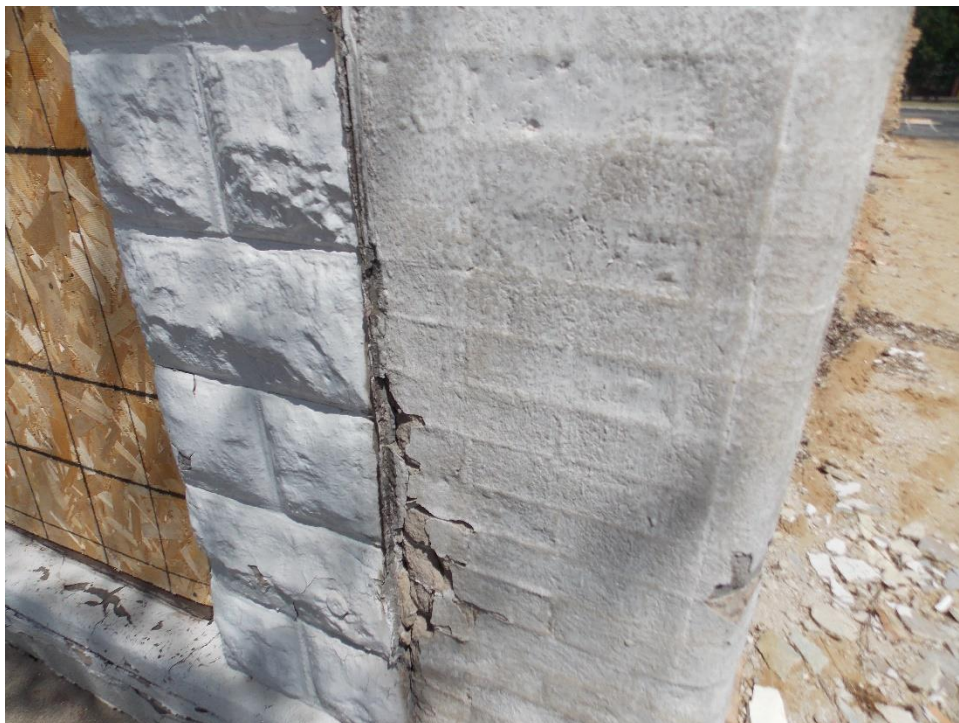
HA-06: Building Joint Caulk

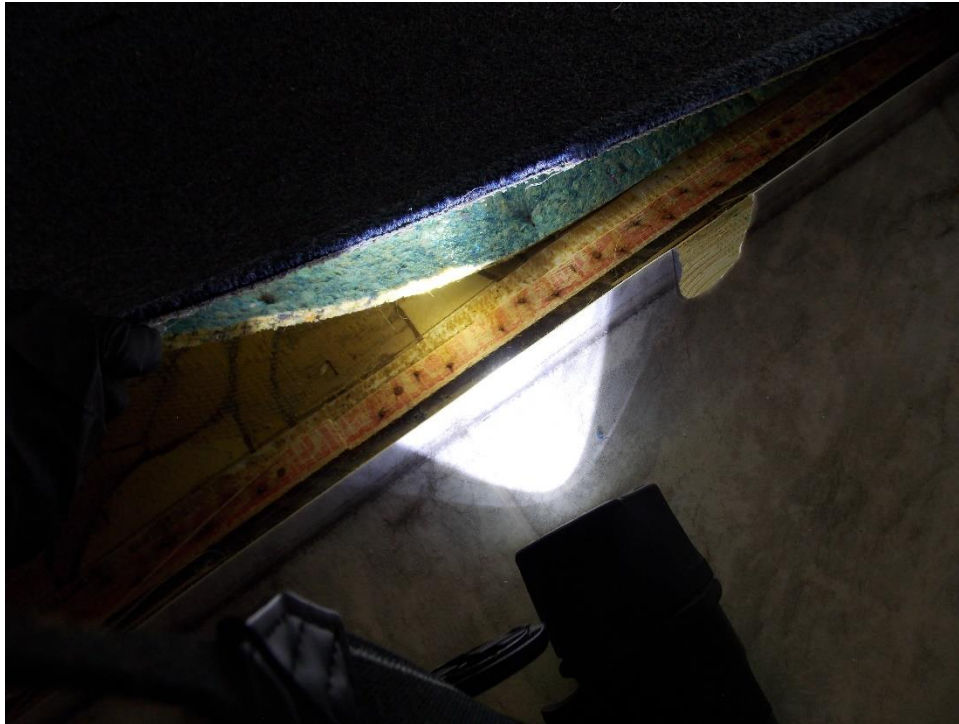
HA-07: Multi-Layer Salon Flooring

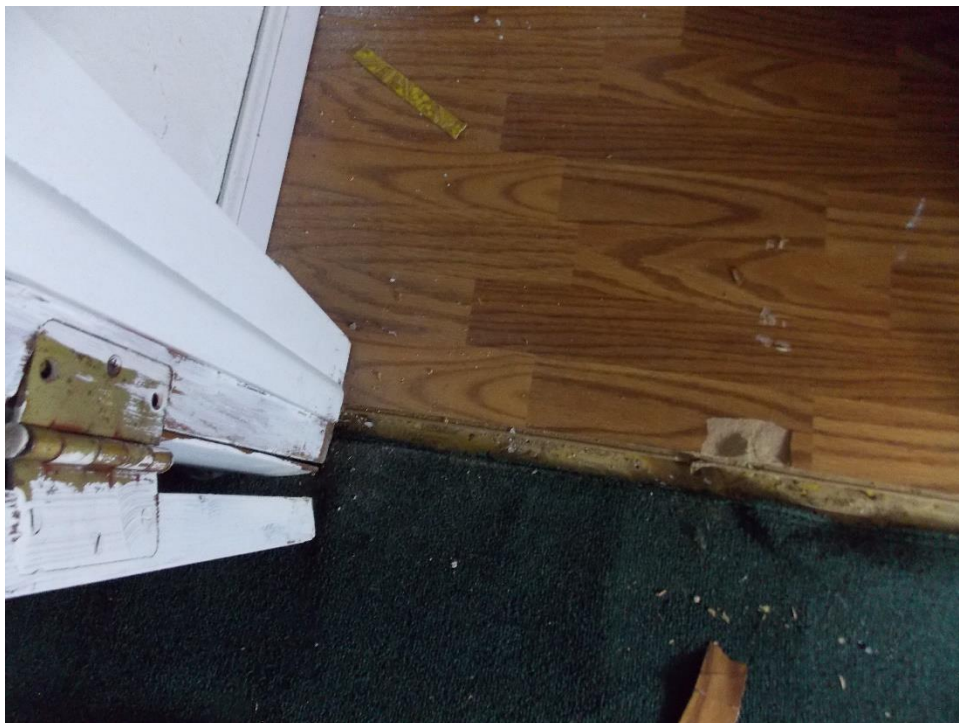
HA-13: Yellow Linoleum

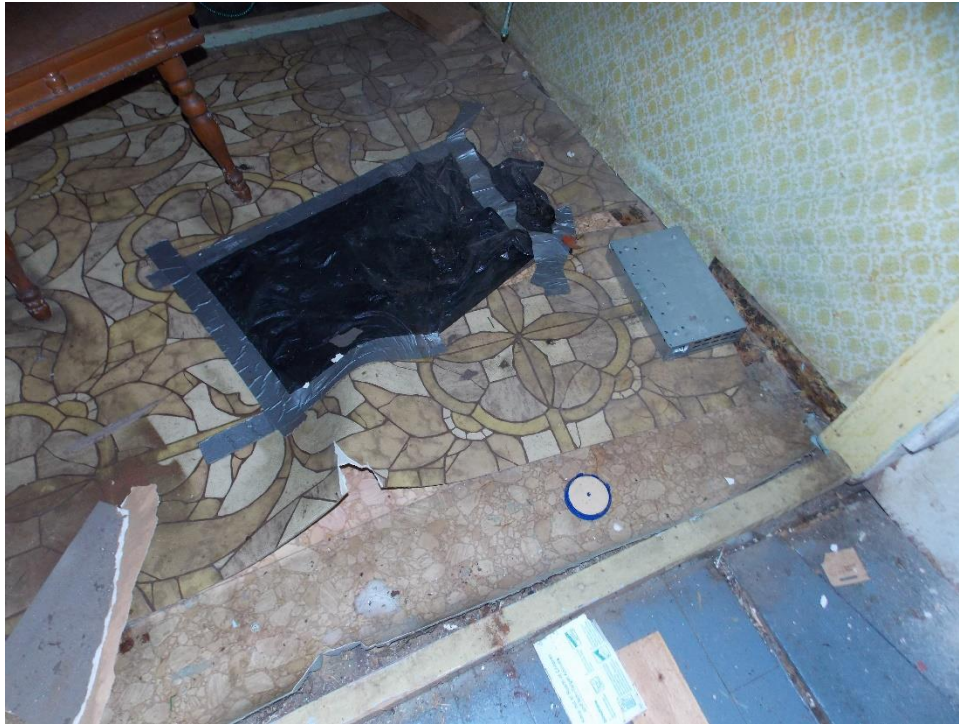
HA-21: Yellow Decorative Stone Pattern Linoleum

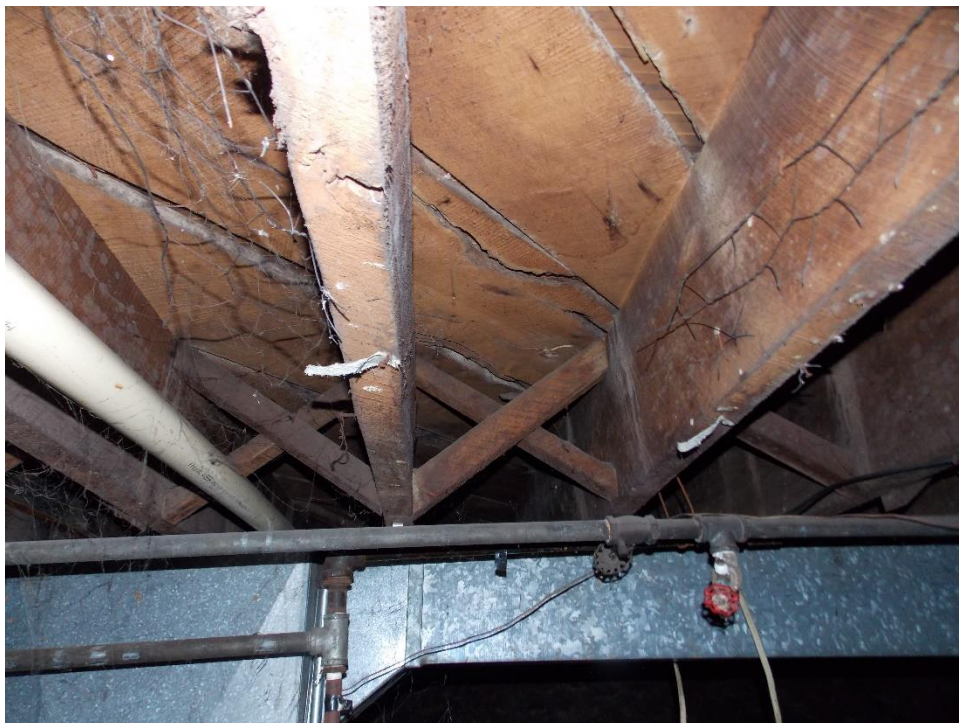
HA-24: Fiberboard

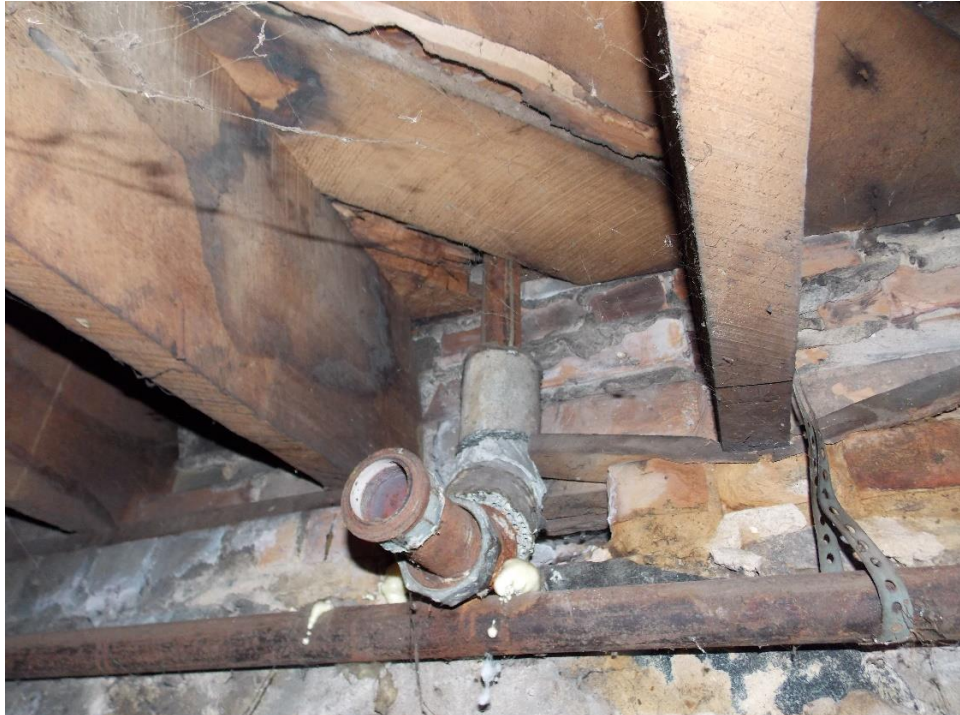
HA-25: Aircell Pipe Insulation

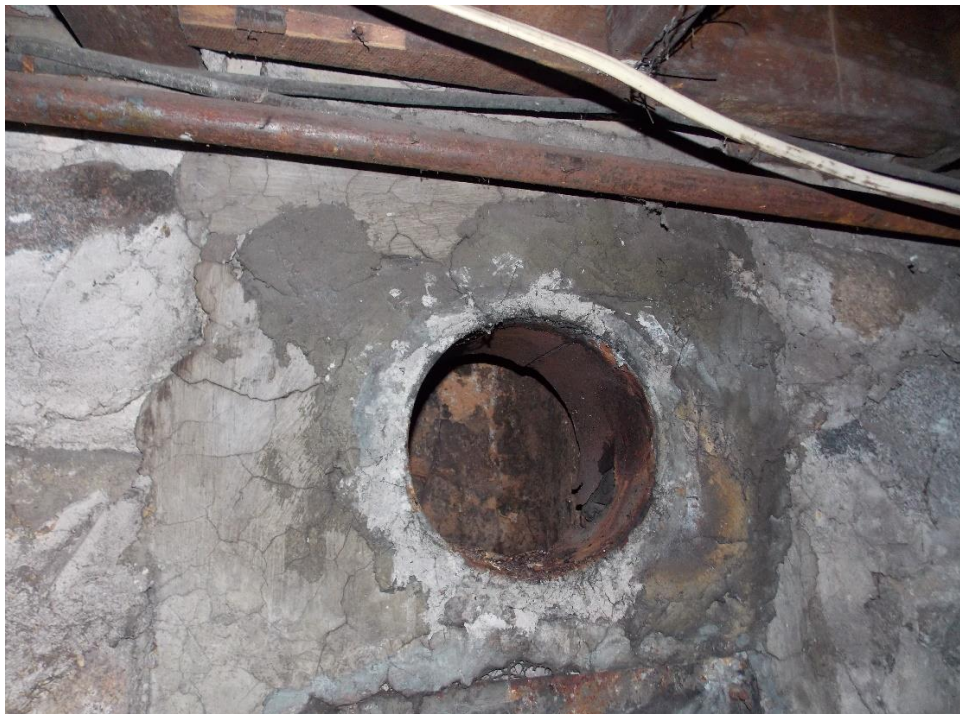
HA-26: Penetration Flue Insulation

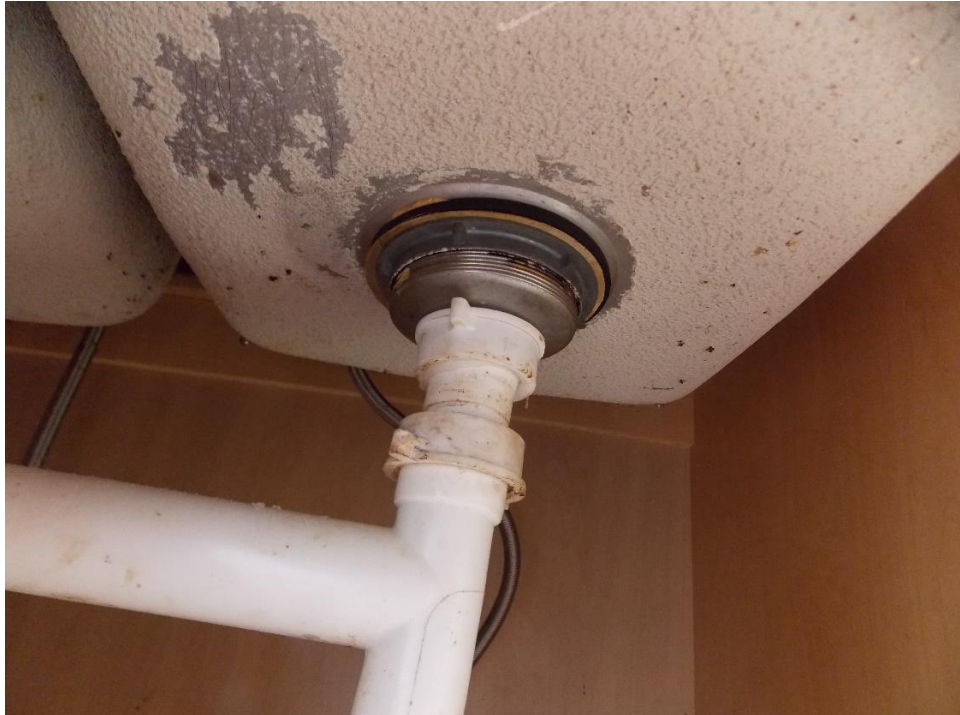
HA-39: White Sink Undercoat

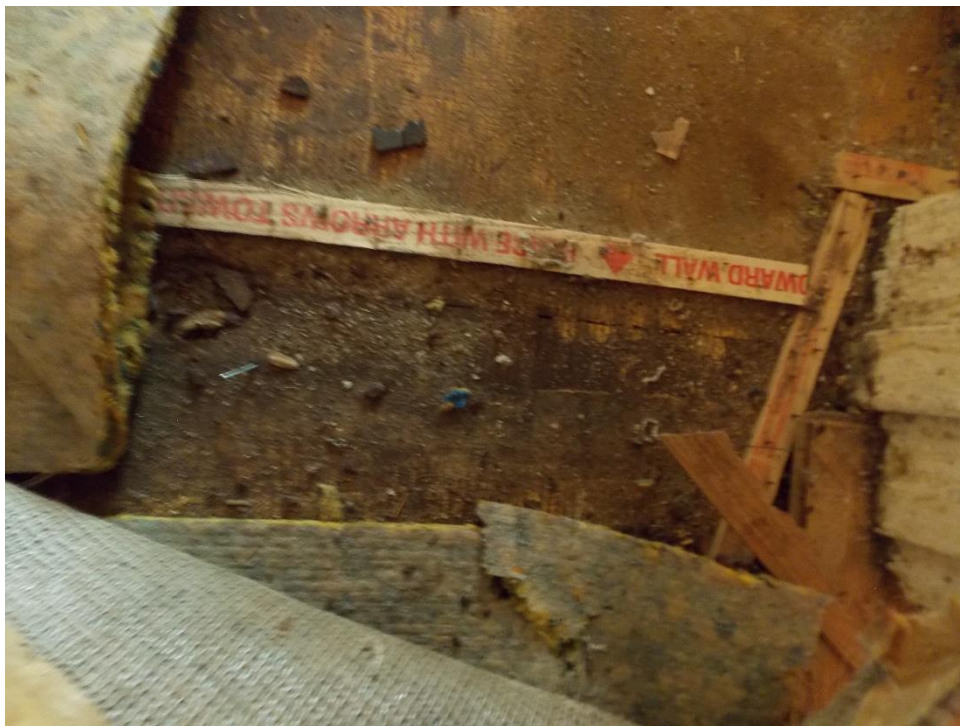
HA-41: 9" x 9" Dark Brown Floor Tile

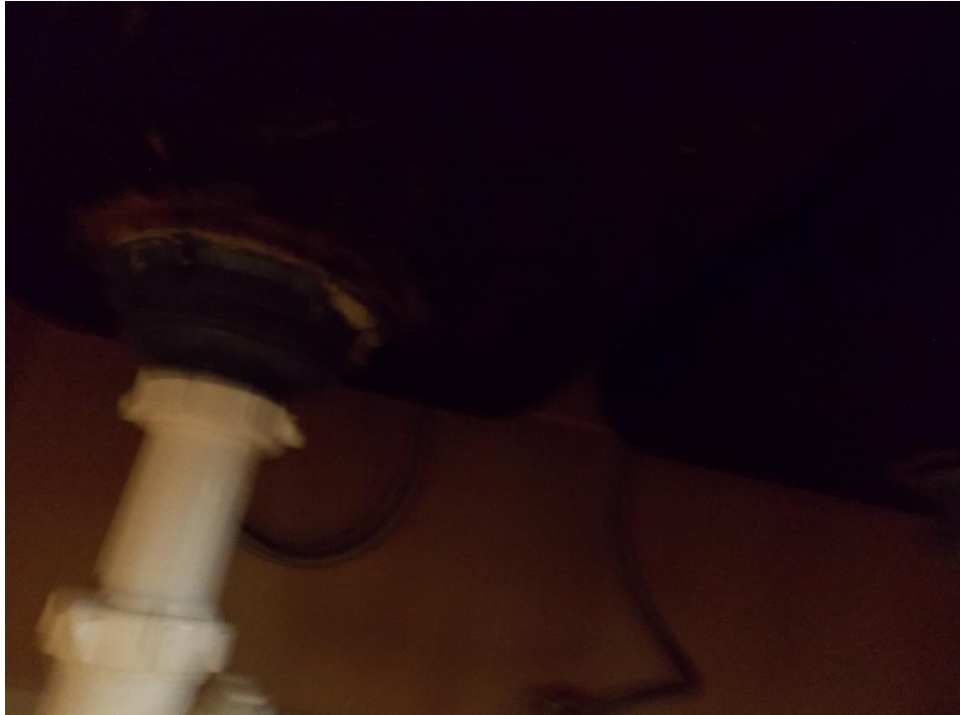
HA-43: Black Sink Undercoat
