# Saddle Lake Lake Level Control Structure Preliminary Engineering Study

**Van Buren County Drain Commissioner**

**Land & Resource Engineering (LRE)**

**Project No. 23-169**

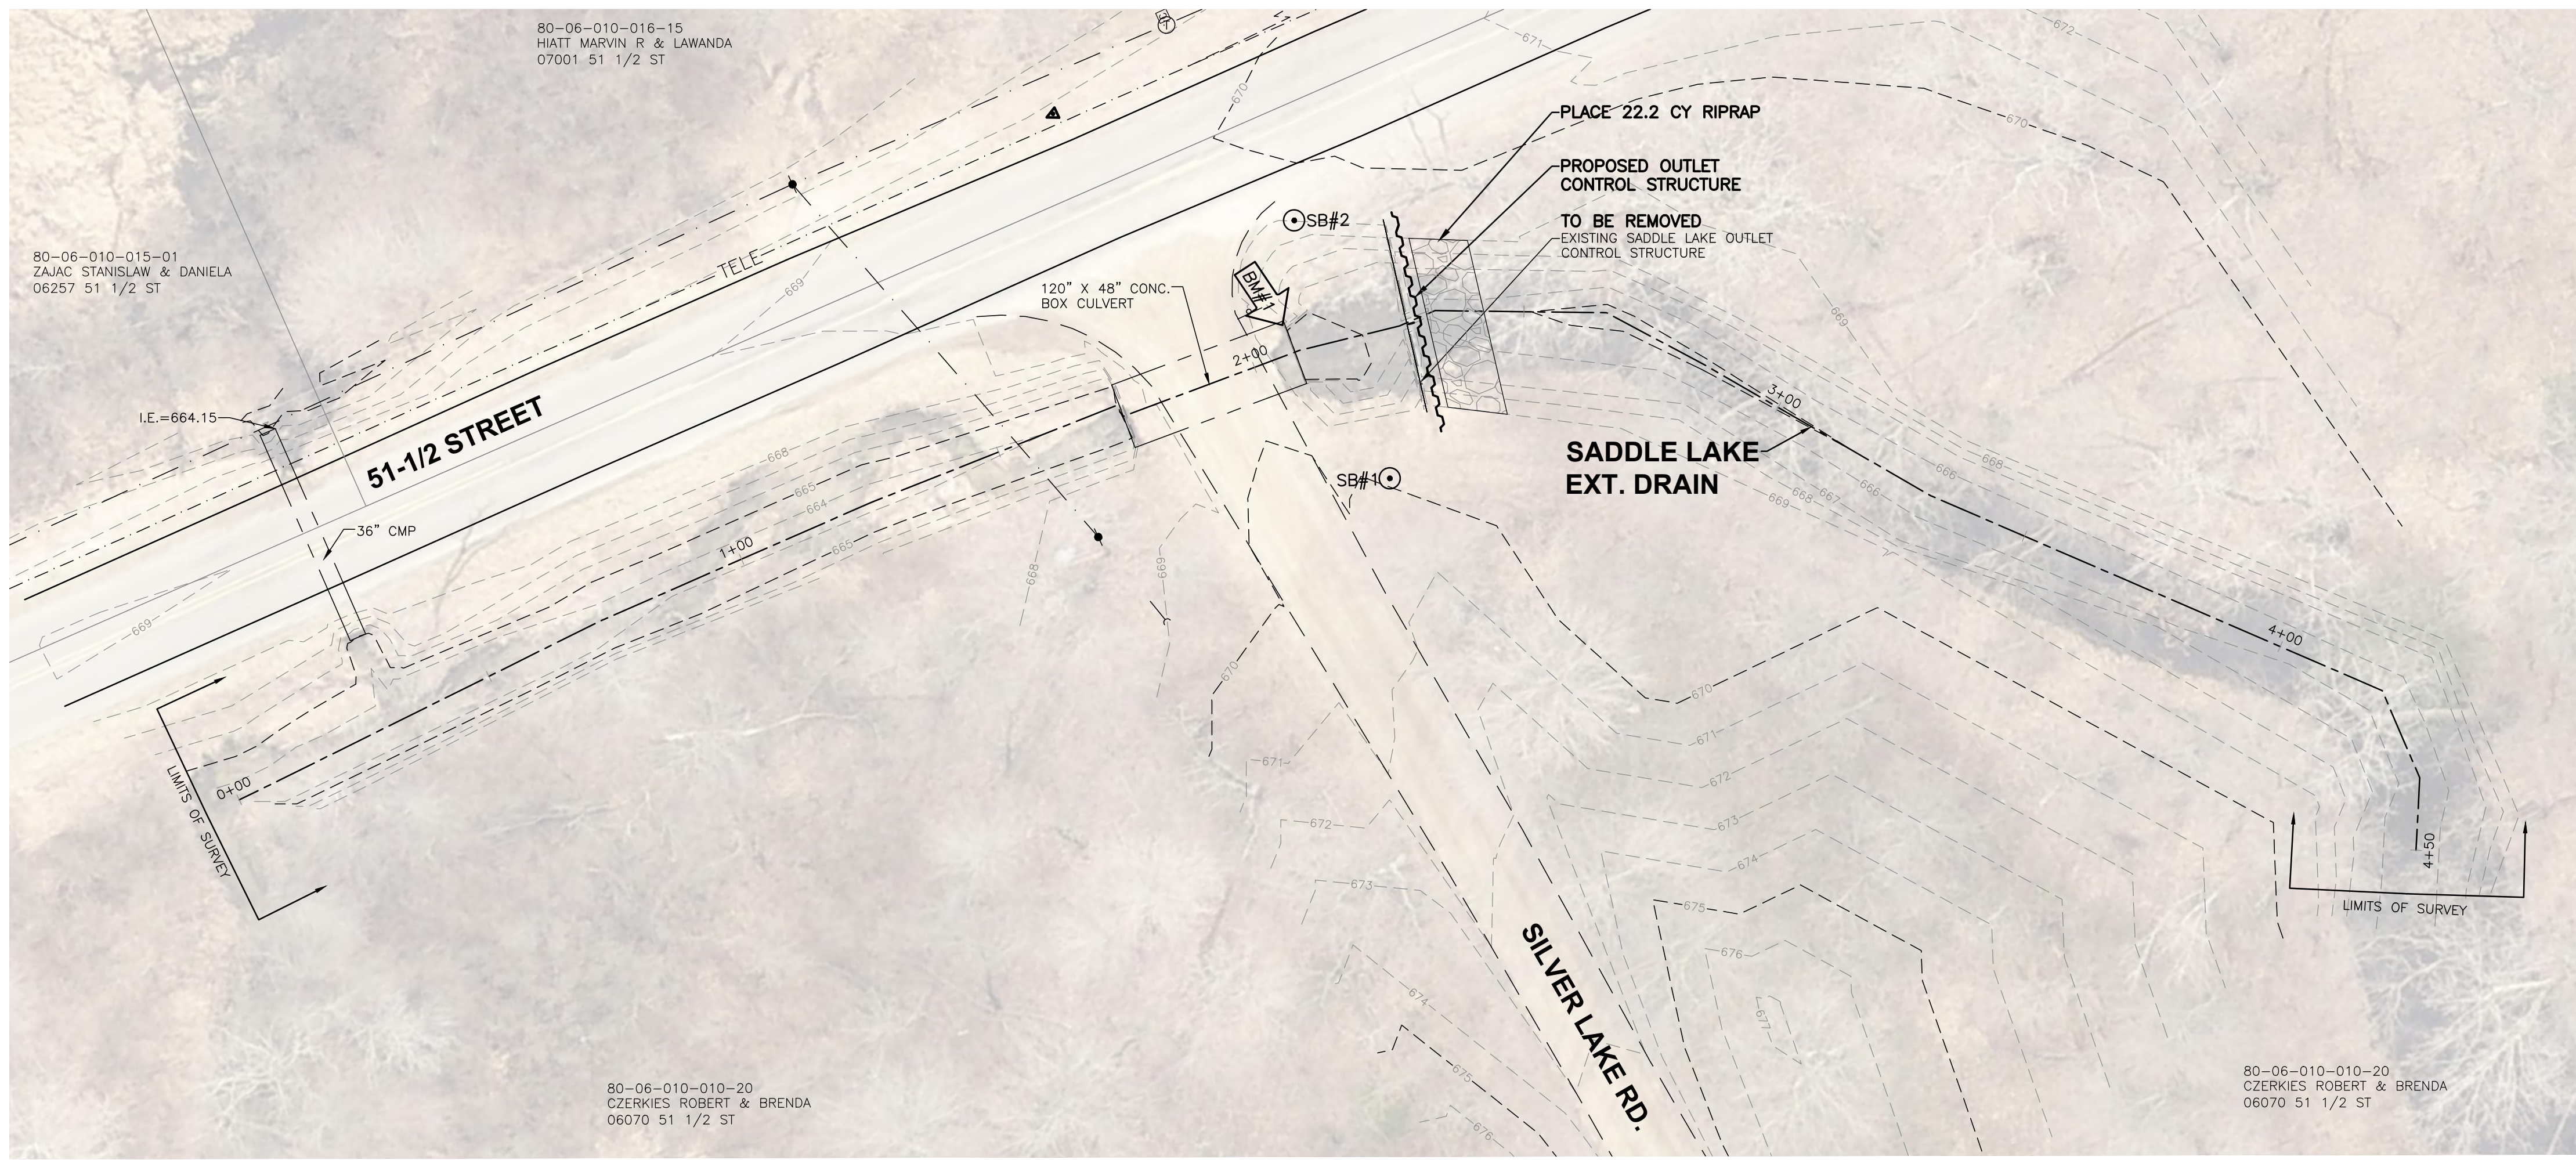
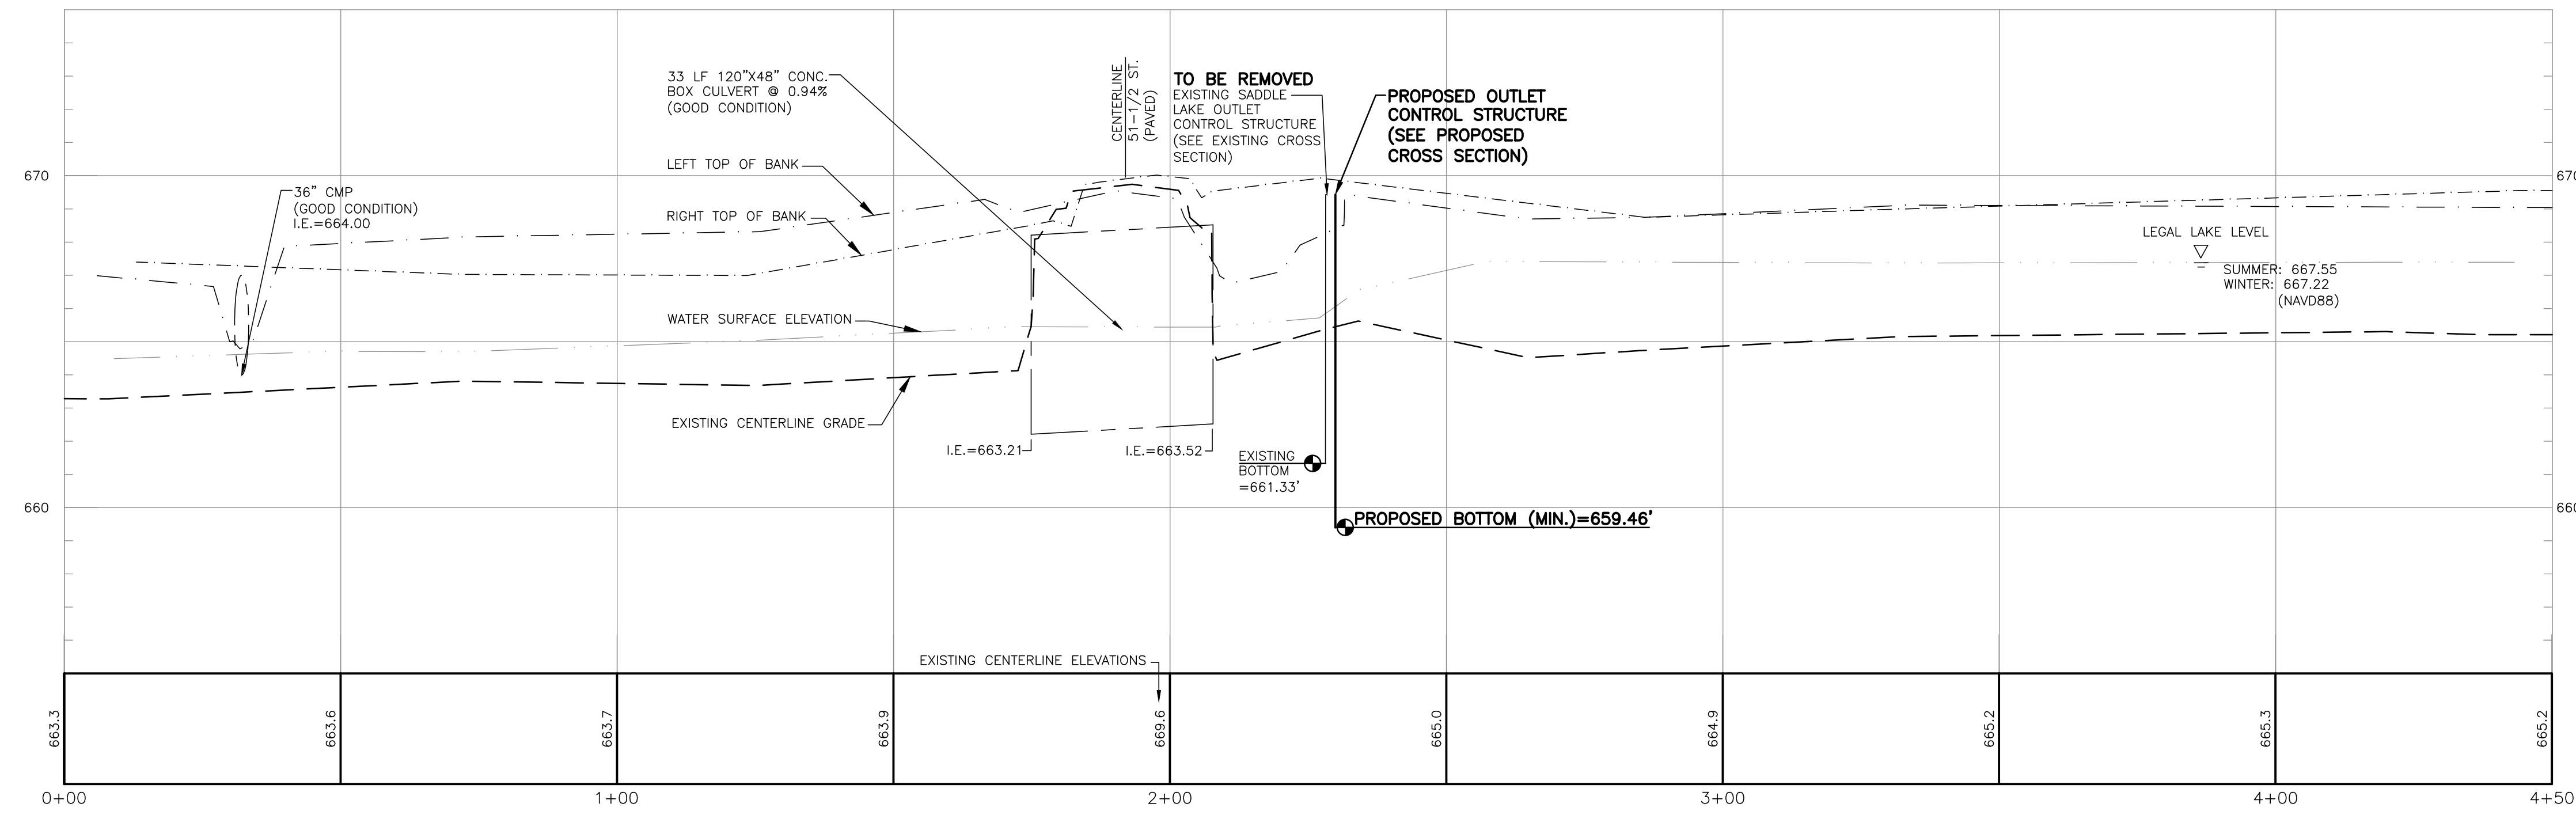
**FIGURE 1 - RECOMMENDATIONS**

MTC's overturning and seepage analysis indicates that the existing structure is *"borderline stable regarding the overturning stability with an estimated Factor of Safety of 1.0 and exit gradient in excess of 0.5."* MTC recommends the sheeting be driven to a minimum elevation of 659.4-feet and have a section modulus of 15.3 cu.in/ft to provide suitable Factors of Safety.

The existing sheet pile Dam has severe corrosion of the steel sheet pile above stream bed resulting in leaks developing through the Dam. The condition of sheeting below the bed of Barber Creek is unknown. The geotechnical analysis results indicate that the existing structure is borderline stable based on the overturning and seepage analysis performed. Additional corrosion of the steel sheeting will develop along the length of the Dam.

This alternative evaluates replacement of the dam with an “In-Kind” structure. The new structure would have sheeting driven to the recommended minimum embedment elevation of 659.4-feet (NAVD-88) to prevent overturning or seepage. This alternative will utilize a single timber stop log to maintain the summer and winter legal levels as ordered by the Court. The crest of the Dam will be set to match the existing structure elevations. This structure would otherwise appear and operate as the existing structure does.

LRE recommends replacing the control structure with a steel sheet pile weir with channel cap in-kind to the existing structure. After discussion with the VBCDC, there have been no complaints regarding the water level elevations in the Lake. Therefore, the in-kind replacement structure was selected.
