# **Van Buren County Land Bank Authority**

## **Request for Proposal General Contractor - Abatement & Building Stabilization**

5 W Main Street  
Hartford, MI 49057

**Attachment 4 – Structural Assessment from Abonmarche (2025)**

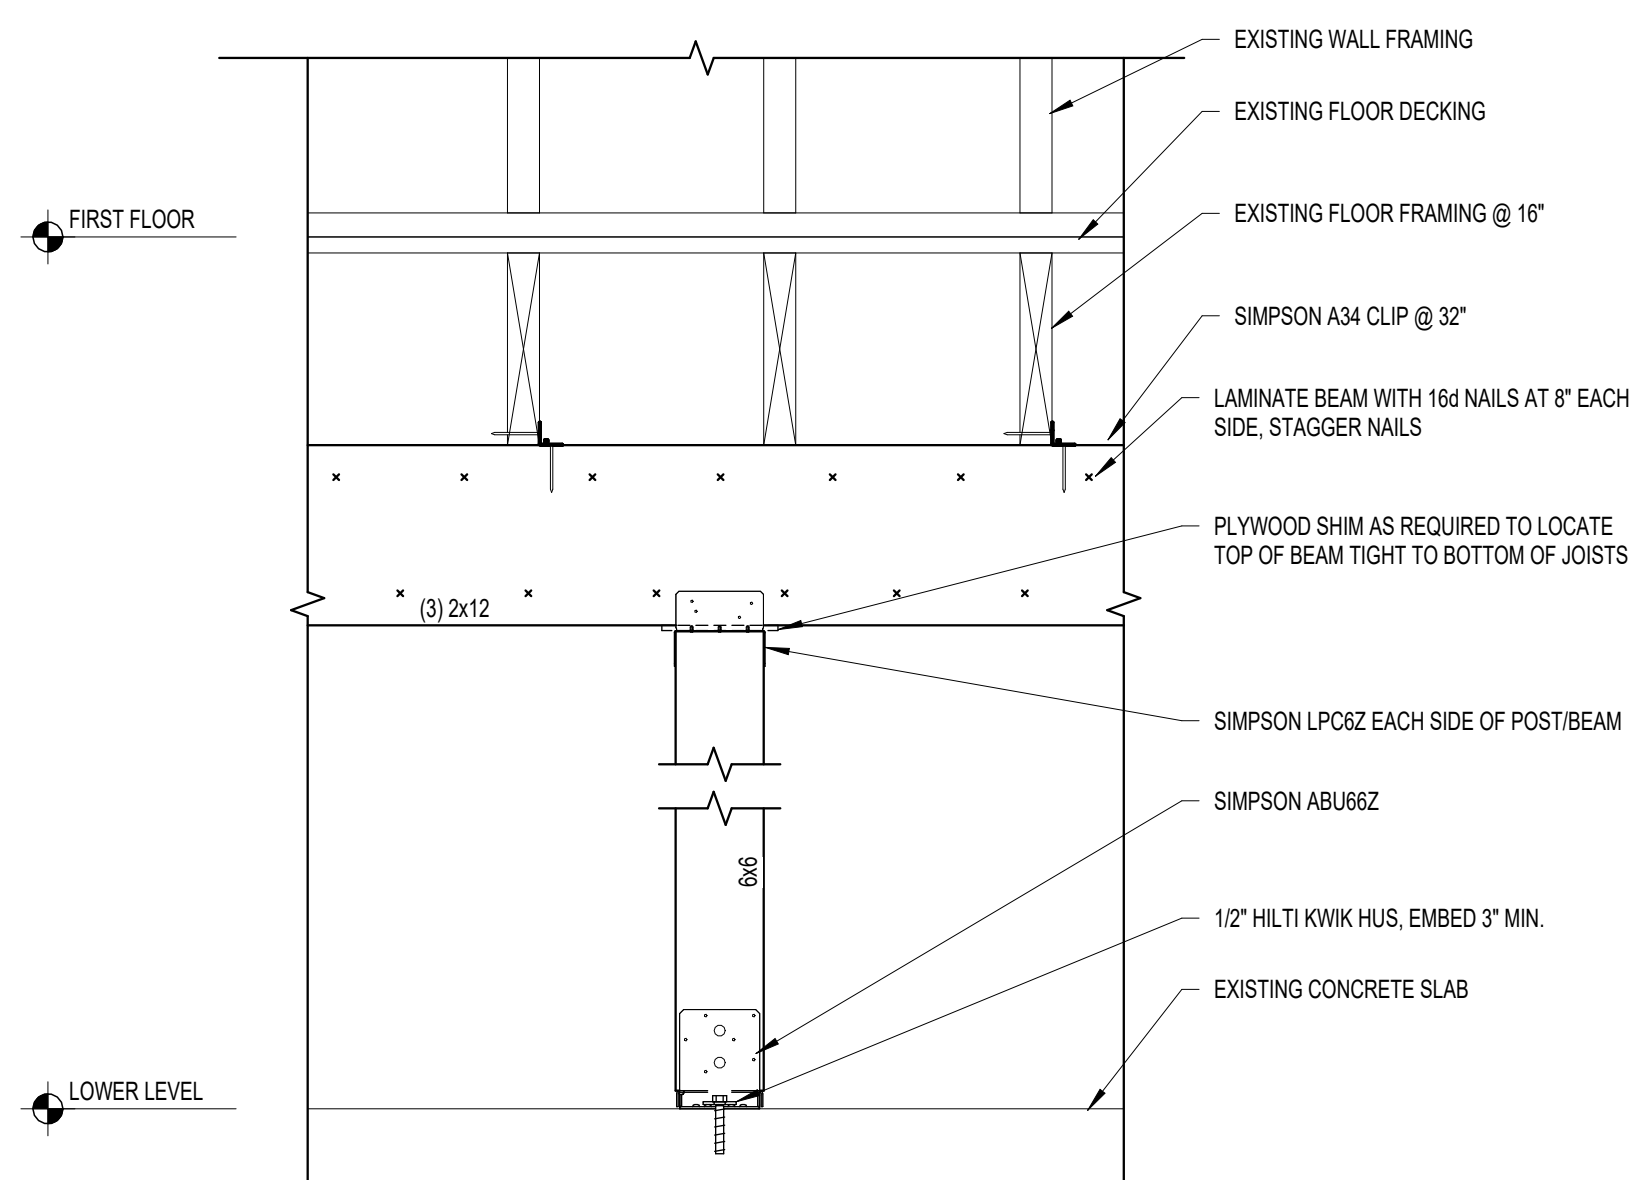
6 STAIR FRAMING REPAIR DETAIL  
 SCALE: 1" = 1'-0"

The lower level walls and framing appear to be in good condition. The basement was noticeably damp and evidence of water infiltration was visible. The posts supporting the framing around the opening have water damage at their base and do not appear to be installed plumb (Photo 1).

We recommend removing and replacing the framing that supports the basement stair opening. Details for this repair can be found in the attached repair drawings.

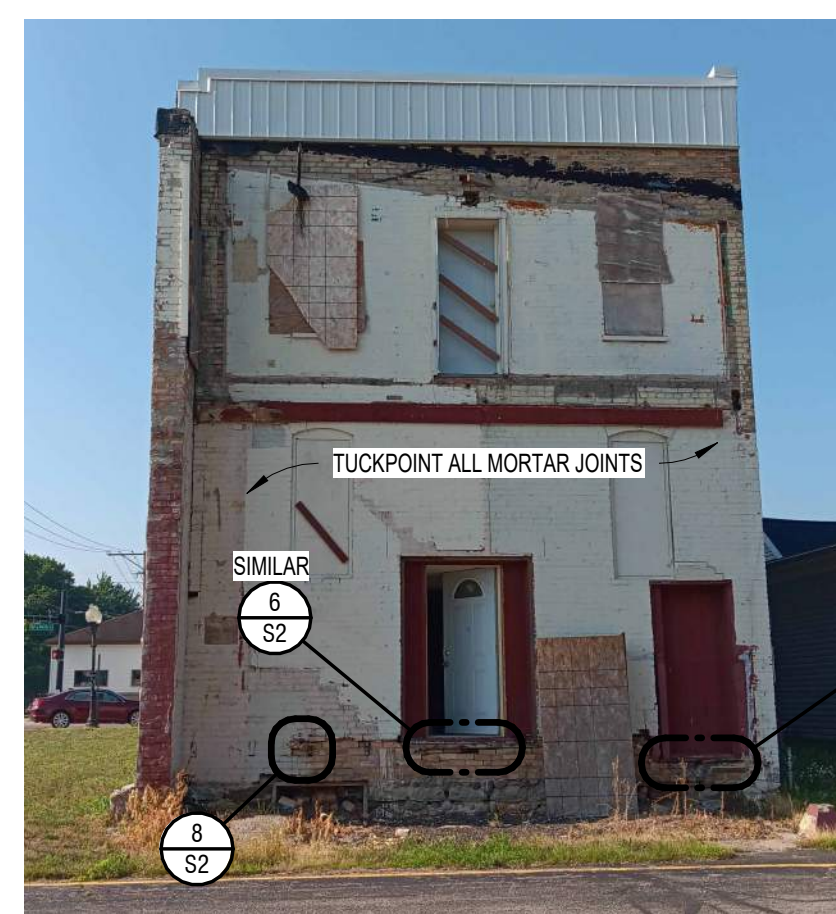
4 NORTH ELEVATION  
 SCALE: 1/8" = 1'-0"

With the removal of the wood framed addition on the north side of the building the brick wall is now exposed. Numerous loose bricks were observed at and around the door openings. Loose bricks are being used as infill for the lower level window openings (Photo 6). Numerous cracks in the mortar joints were observed in the wall. There is existing wood framing protruding through the wall at the first floor elevation that was cut off as part of the demolition of the north stair (Photo 7).

We recommend that all loose and missing bricks be reset and/or replaced where necessary. These locations are primarily along the west and north walls. All deteriorated mortar joints should be repointed. The existing wood framing protruding out of the north wall should be removed and the resulting opening should be infilled with new brick. The contractor should verify that the framing is not part of the existing floor framing on the inside of the building. If it is found to be part of the floor framing it should be cut back sufficiently such that at least one brick wythe can be installed over it.

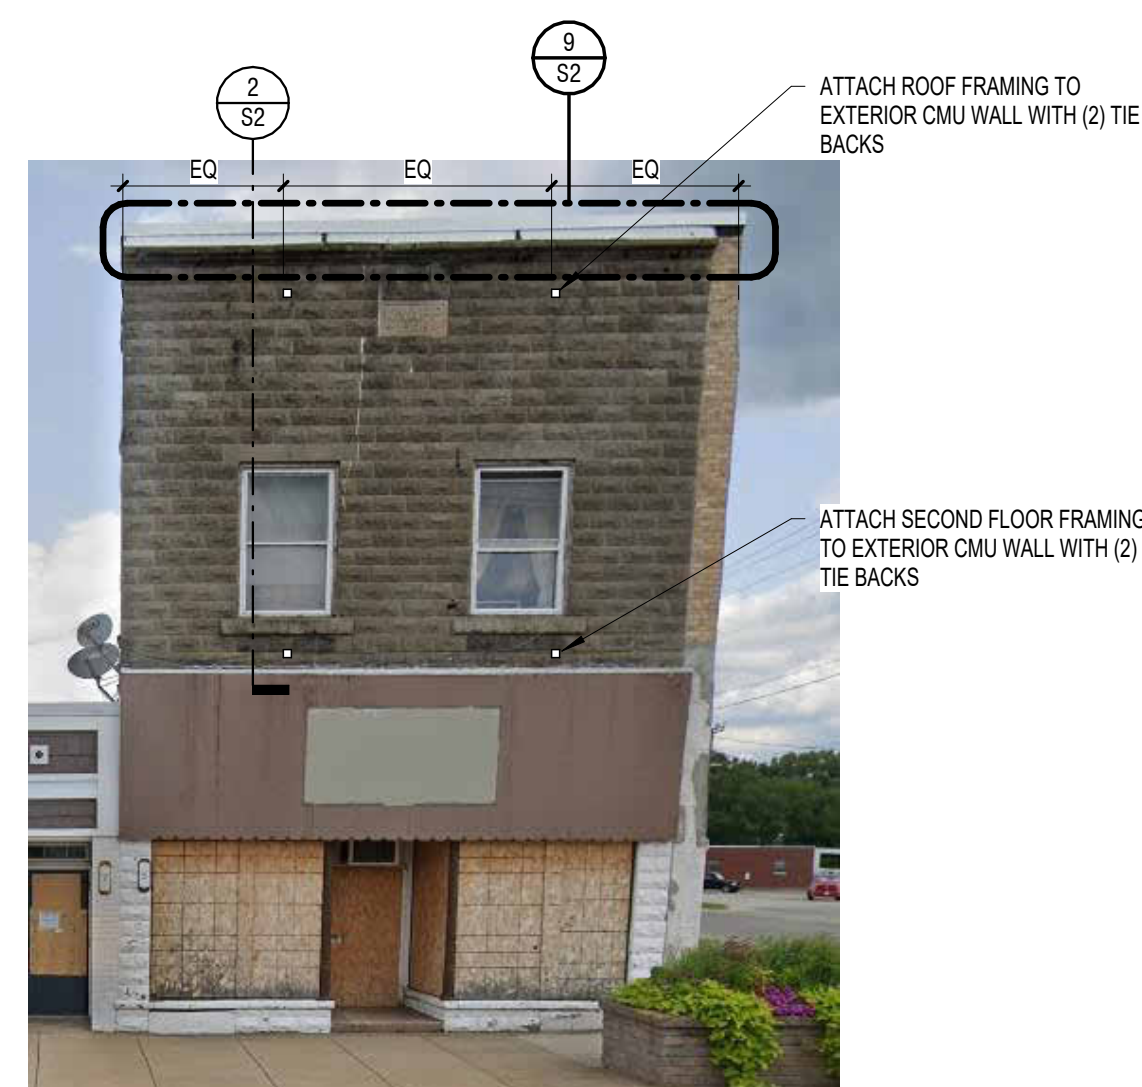
3 SOUTH ELEVATION  
 SCALE: 1/8" = 1'-0"

The south face of the building is constructed with concrete masonry units (CMU). The south wall is built integrally with the west wall with intermittent CMU's mortared to the brick (Photo 8). There is a gap between the south and west walls and the south wall appears to be separating from the building. The cornice at the top of the wall appears to be cracked and broken (Photo 9).

We recommend that all the joints connecting the south CMU wall to the east and west brick walls are repointed to ensure a positive connection between the two walls. The vertical joint between the walls should be filled with backer rod and sealed. We recommend that the connection between the wall and the second and third floor framing be investigated. The CMU wall should be attached to the floor and roof framing per the detail in the attached drawings. The cornice at the top of the south wall should be investigated more closely. We recommend that any broken, cracked, or loose pieces be removed. They appear to be hazards to pedestrians on the sidewalk below and should be repaired or removed as soon as possible.

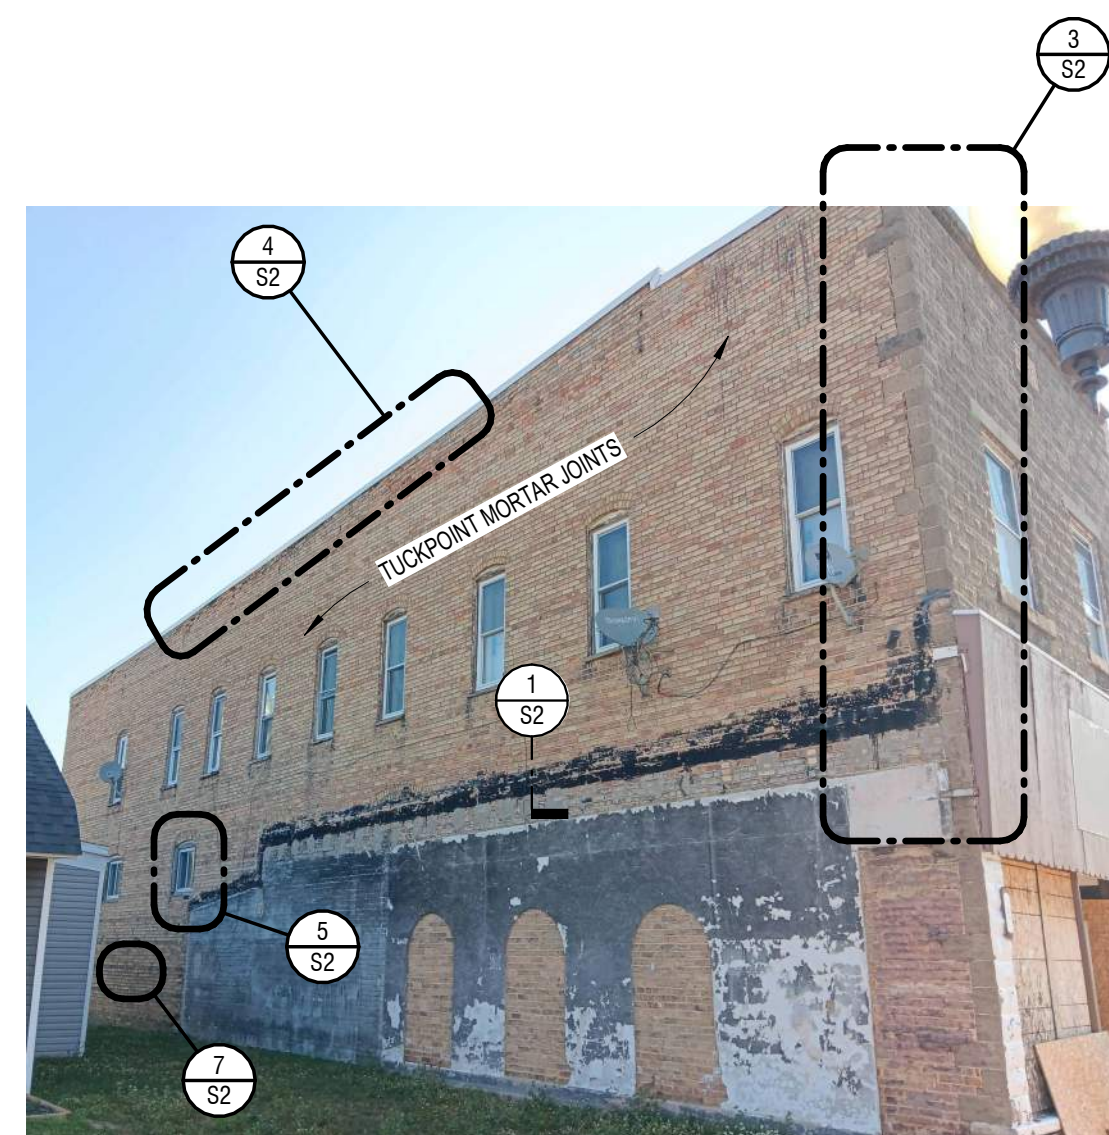
2 WEST ELEVATION  
 SCALE: 1/8" = 1'-0"

The west side of the building consists of exposed brick and appears to be deteriorating along the roof parapet elevation (Photo 2). Cracked, spalled, and missing bricks were observed along the length of the parapet cap on the west side of the building. Missing bricks were also observed along the base of the wall and around window openings (Photo 3)(Photo 4)(Photo 5).

We recommend that access to the roof be provided to determine what the condition of the existing roof is and determine if any water is infiltrating into the roof framing. The brick along the top of the roof parapet should be repaired. It is possible that water is passing through the deteriorating brick at the parapet elevation and causing damage to the roof framing.
